Cross-section Microscopy Report

Exterior Paint Research -- C100 Automotive Museum Building Balboa State Park, San Diego, California

Date: May 24, 2020

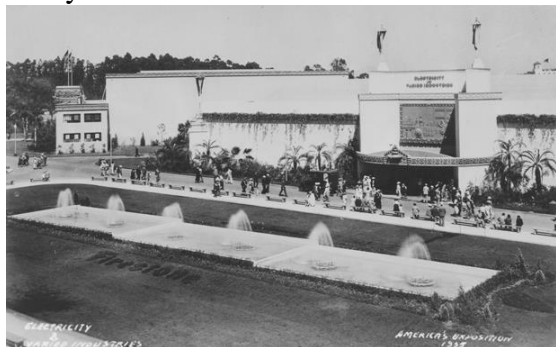
Gymnasium²

1. C100 Gymnasium. 1935 east Gymnasium wall, far right front corner.
2. C100 Gymnasium. South Gymnasium wall, 1935 wall to right of later pair of exit doors.
3. C100 Gymnasium. South Gymnasium wall, intact 1935 wall above handrail.
4. C100 Federal Building. Peeling late 20th-century paint next to left-hand door reveals what appears to be the original brushed 1935 paint layer.

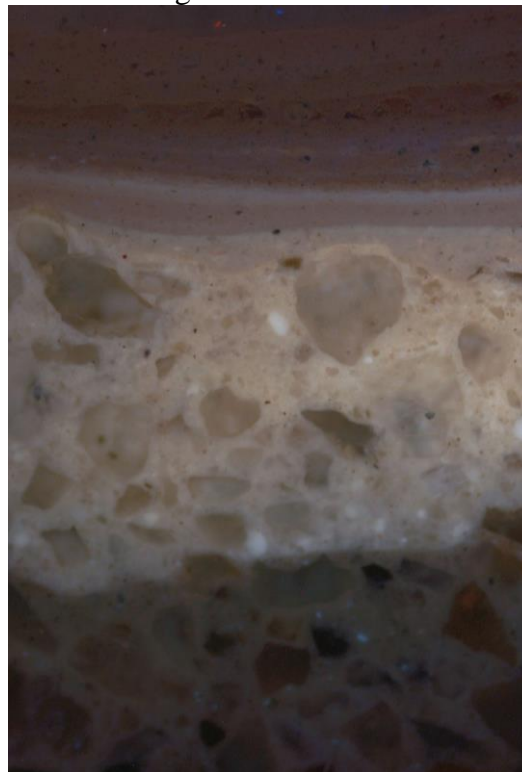
1. C100 Gymnasium. 1935 east Gymnasium wall, far right front corner.

The comparative evidence in sample 1 suggests that the first presentation layer on the building was a light tannish sanded paint or stucco coating. This coating has a grimy, slightly eroded surface. It is followed by nine generations of finely ground, evenly mixed, clean and smoothly applied oil-bound paints. All of these paints are nonfluorescent in reflected ultraviolet light. The physical properties of these paints are more consistent with post-1950s commercially prepared paints.

There is a slight positive reaction for oils in the sanded stucco or paint at the bottom, which might be part of the binder, or oil that soaked into this porous coating from later paint applications. Binding media analysis with biological fluorochromes confirms the presence of oil in all the paints (with DCF), as well as carbohydrates in the binders which could be modern bulking agents and/or natural gum additives (with TTC). None of the paints have protein components in their binders.

The color matching and measurement process shows that the first sanded presentation layer is a good match to the Sherwin Williams SW 6114 “Bagel” identified by Will Chandler as part of his recent investigation.

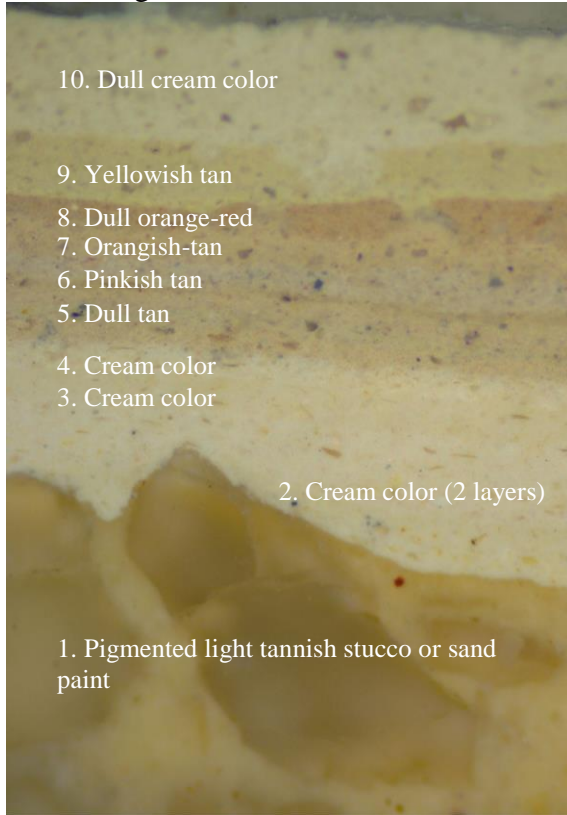
1. C100 Gymnasium. 1935 east Gymnasium wall, far right front corner.

Visible Light 100X

Ultraviolet Light 100X

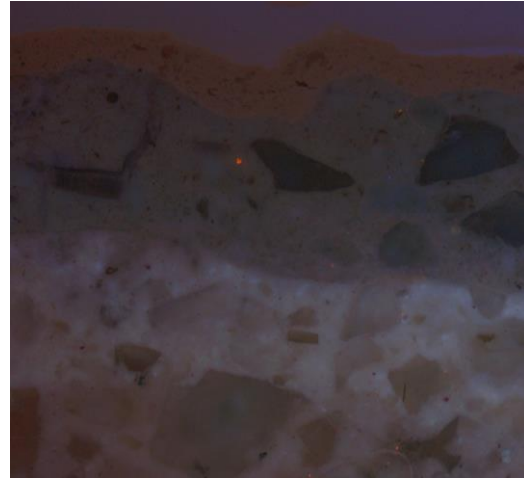
2. C100 Gymnasium. South Gymnasium wall, 1935 wall to right of later pair of exit doors.

Analysis of sample 2 shows that the same light tannish stucco or sanded paint is present at the bottom of this cross-section, but it is covered over with a later grayish cementitious layer, which was possibly applied as patching. Only the most recent paint identified as generation 10 is present on top of this grayish repair layer.

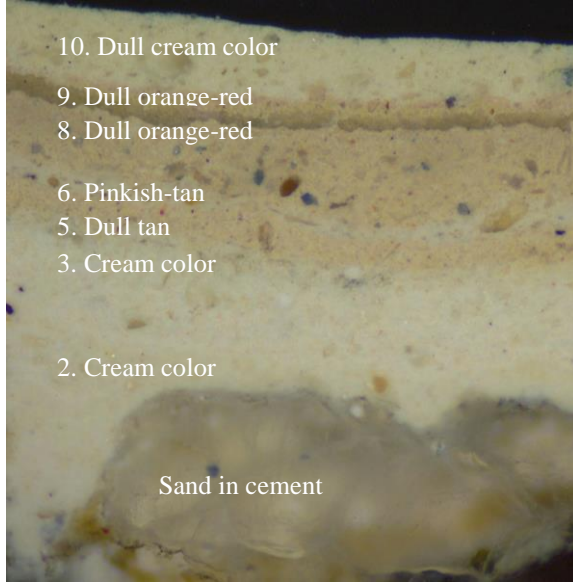
3. C100 Gymnasium. South Gymnasium wall, intact 1935 wall above handrail.

Sample 3 is missing the earliest tannish sandy stucco or paint, but it retains most of the other oil-bound paints identified in sample 3.

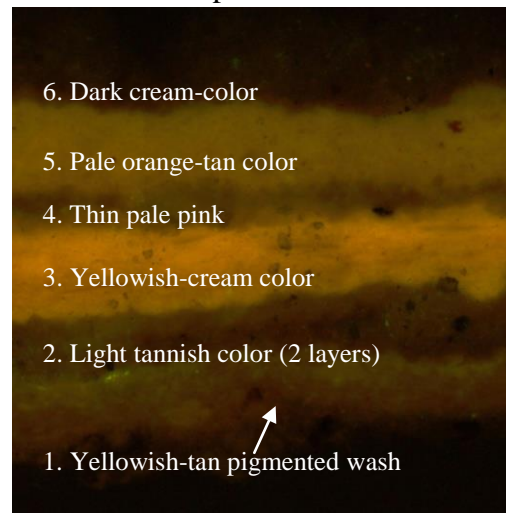
4. C100 Federal Building. Peeling late 20th-century paint next to left-hand door reveals what appears to be the original brushed 1935 paint layer.

UV Light & TTC for carbohydrates 100X UV Light & DCF for oils 100X

+ reactions in all paints

+ reactions in all paints but generation 1

(paints partially softened on exposure to ethanol)

B-2A filter 100X

B-2A filter & FITC for proteins

No reactions for proteins

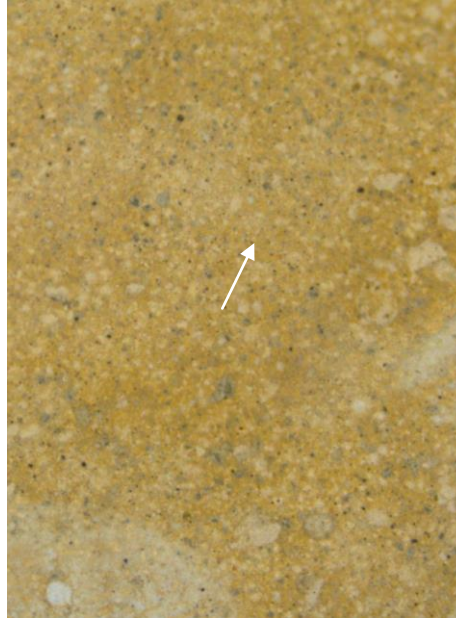
Sample 4 from Federal Building

Underside of detached paint flake at 20X

Cross-section analysis shows that the original paint is a thinly applied, tannish-yellow washy layer. The commercial match #2161-40 is an excellent visual match to the most intact areas of the earliest tannish-yellow exterior wall paint when the uncast samples and the cross-sections are examined by eye at 30X magnification under a color-corrected light source. Binding media analysis indicates that the original paint may be some early form of mineral emulsion paint. This paint should be replicated in a flat gloss level to match the original matte appearance of the leanly bound paint.

Benjamin Moore 2161-40 “Acorn”
